# *PADDLESWORTH CONSERVATION AREA*

## *Introduction*

# PADDLESWORTH TOWNSCAPE ANALYSIS

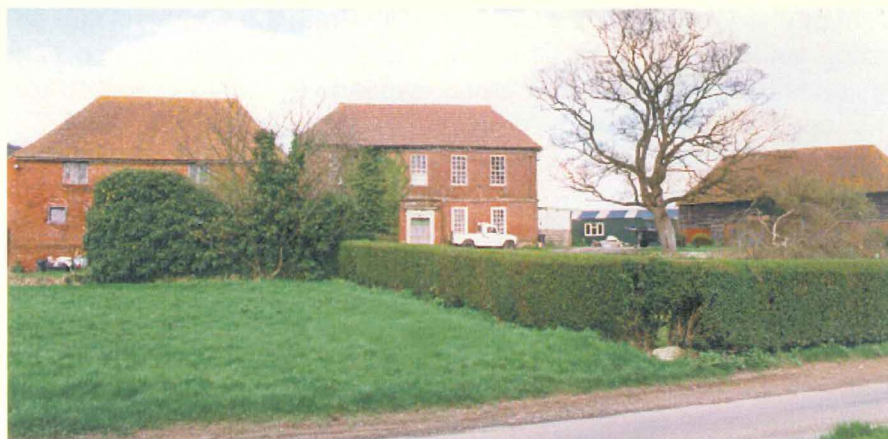
Plan 1 shows the extent of the Conservation Area and the footpaths and tracks which meet here.

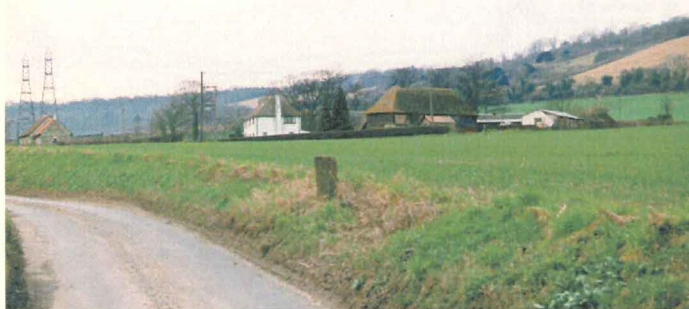
The Church is built from Ragstone but other buildings are generally constructed from red brick with some timber cladding on the barns. The later dwellings are white painted render/brick. Roofs are predominantly hipped with only the Church and the 19<sup>th</sup> Century Paddlesworth Cottage being

gable-ended. Two of the barns have plain clay tiled roofs whilst the Old and New farmhouses have concrete tile roofs. All properties are two storeys or less. Considerable repair work has been carried out to the listed barns but the other buildings are still in need of repair and restoration.
